Freshwater CyanoHAB Monitoring

NJDEP Division of Water Monitoring & Standards
Bureau of Freshwater and
Biological Monitoring

Tom Miller, Principal Biologist September 23, 2015

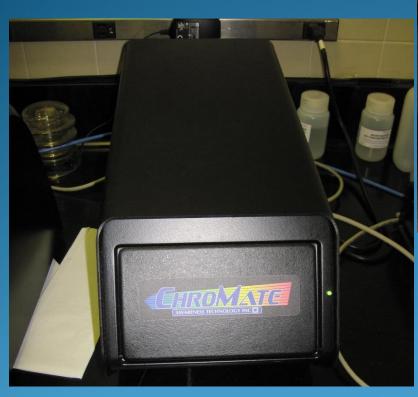
- ABRAXIS Plate Reader and Kits to perform:
 - Microcystins ELISA (Enzyme-Linked Immunosorbent Assay). Method established through routine Lake Network monitoring.
 - Cylindrospermopsin ELISA. **2015 New capacity for BFBM.
 - Anatoxin a Receptor-Binding Assay (RBA). **2015 New capacity for BFBM.

- Microcystins (approx. 65 variants)
 - Method –ELISA
 - Detection level = 0.10 μg/l
- Cylindrospermopsin
 - Method ELISA.
 - Detection level = 0.050 μg/l
- Anatoxin-a
 - Method RBA
 - Detection level = 10 μg/l

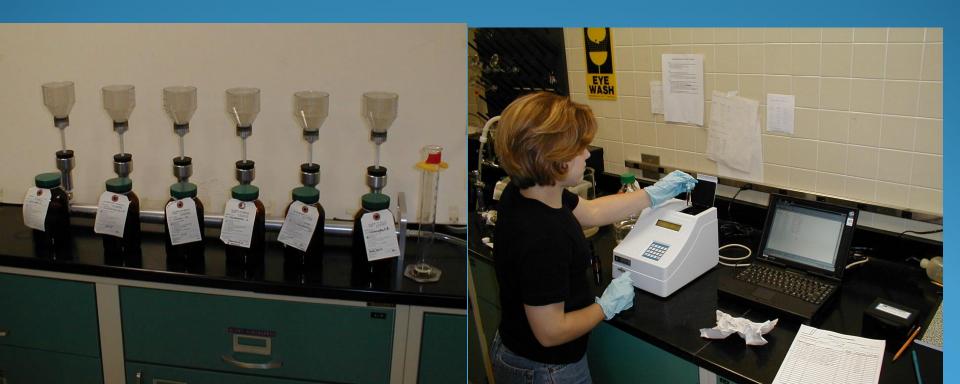
- Combined with existing Chlorophyll a capacity
- Method EPA Method 445.0
- Detection level = 0.05 μg/l

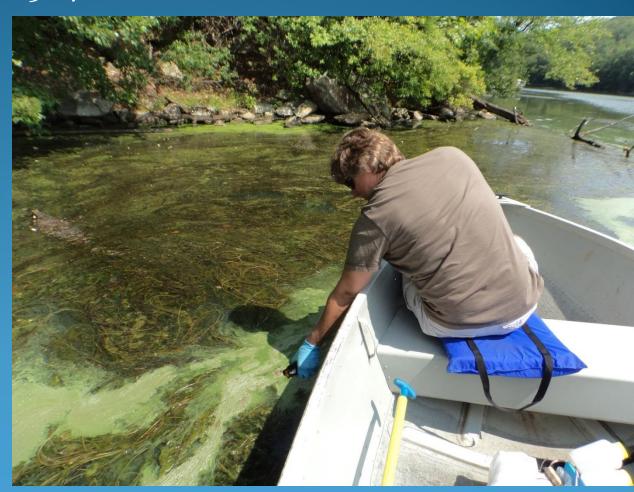
Lake Hopatcong, BFBM Sampling

- Alerted by Lake Commission
- Samples collected on 8/5/14

- Microcystin
- Chlorophyll 'a'
- Cell identification

- Dissolved Oxygen
- Conductivity
- Temperature
- pH
- Turbidity
- Secchi Depth
